Pipeline Life Extension

Installation: Subsea gas pipeline

Project: Subsea pipeline life extension. The pipeline is operating since 1990.

Subsea Pipeline Life Extension¹

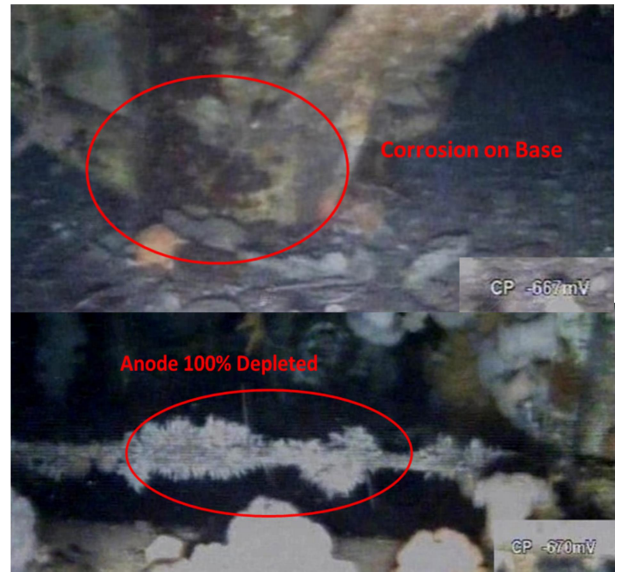
Corrosion on the Protection Frame

The only problem was found in the cathodic protection system of a protection structure. The photograph shows that the anodes were totally depleted.

Based on the DNV-RP-B401 standard, a new cathodic protection system was designed using Al-Zn-In Alloy sacrificial anodes.

The identified remedial works on the protection frame and the recommended maintenance shall be conducted; more details are given in next table.
